Manhole Inspection Summary

Manhole # S290__052MH

Location Address: **BEHIND 820 W CROSS ST**

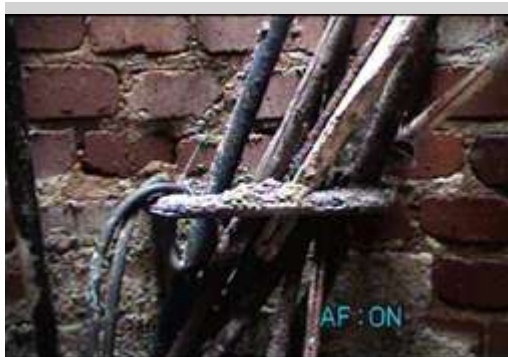
Miscellaneous

DEBRIS BETWEEN CORRODED RUNGS

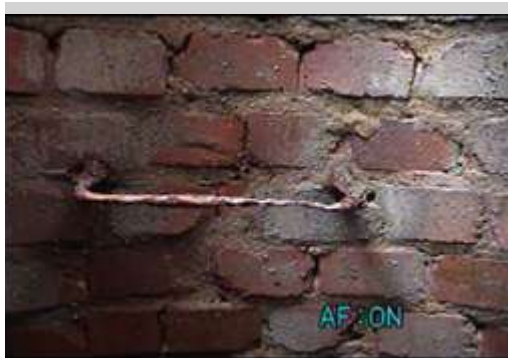
Defect 5

Count: **4** Missing: **0** ☒ **Corroded**

CORRODED RUNGS

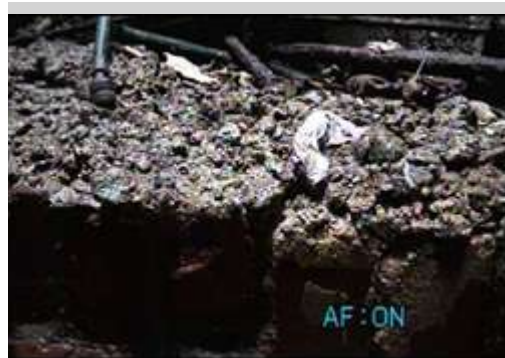
Defect 3

Condition: ☐ Sound ☐ Cracked ☐ Root Intrusion ☐ Deteriorated ☐ Leaks ☒ **Debris**

DEBRIS ON BENCH

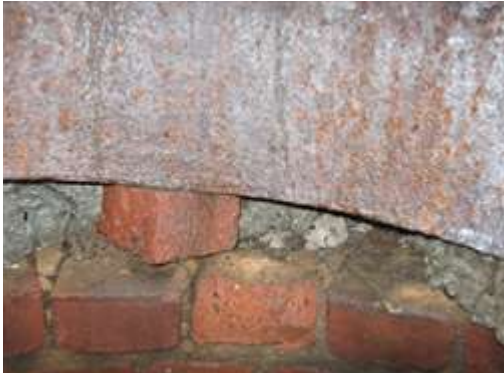
Defect 2

Condition: ☐ Sound ☐ Cracked ☐ Root Intrusion ☒ **Loose Brick** ☐ Deteriorated

BROKEN LOOSE BRICKS

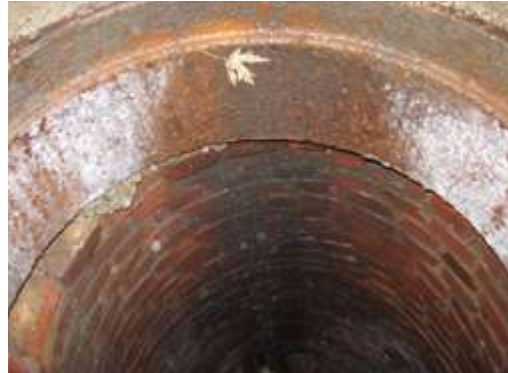
Defect 1

Condition: ☐ Sound ☐ Cracked ☒ **Leaks**

Infiltration: ☐ None ☒ **Joint** ☐ Cracks ☐ Mortar ☐ Roots ☐ Wall

frame offset; infiltration from chimney joint
& from frame
